NASA TN D-1861

**EXPERIMENTAL INVESTIGATION OF
INSULATING REFRACTORY-METAL
HEAT-SHIELD PANELS**

by Gregory R. Wichorek and Bland A. Stein
Langley Research Center
Langley Station, Hampton, Va.

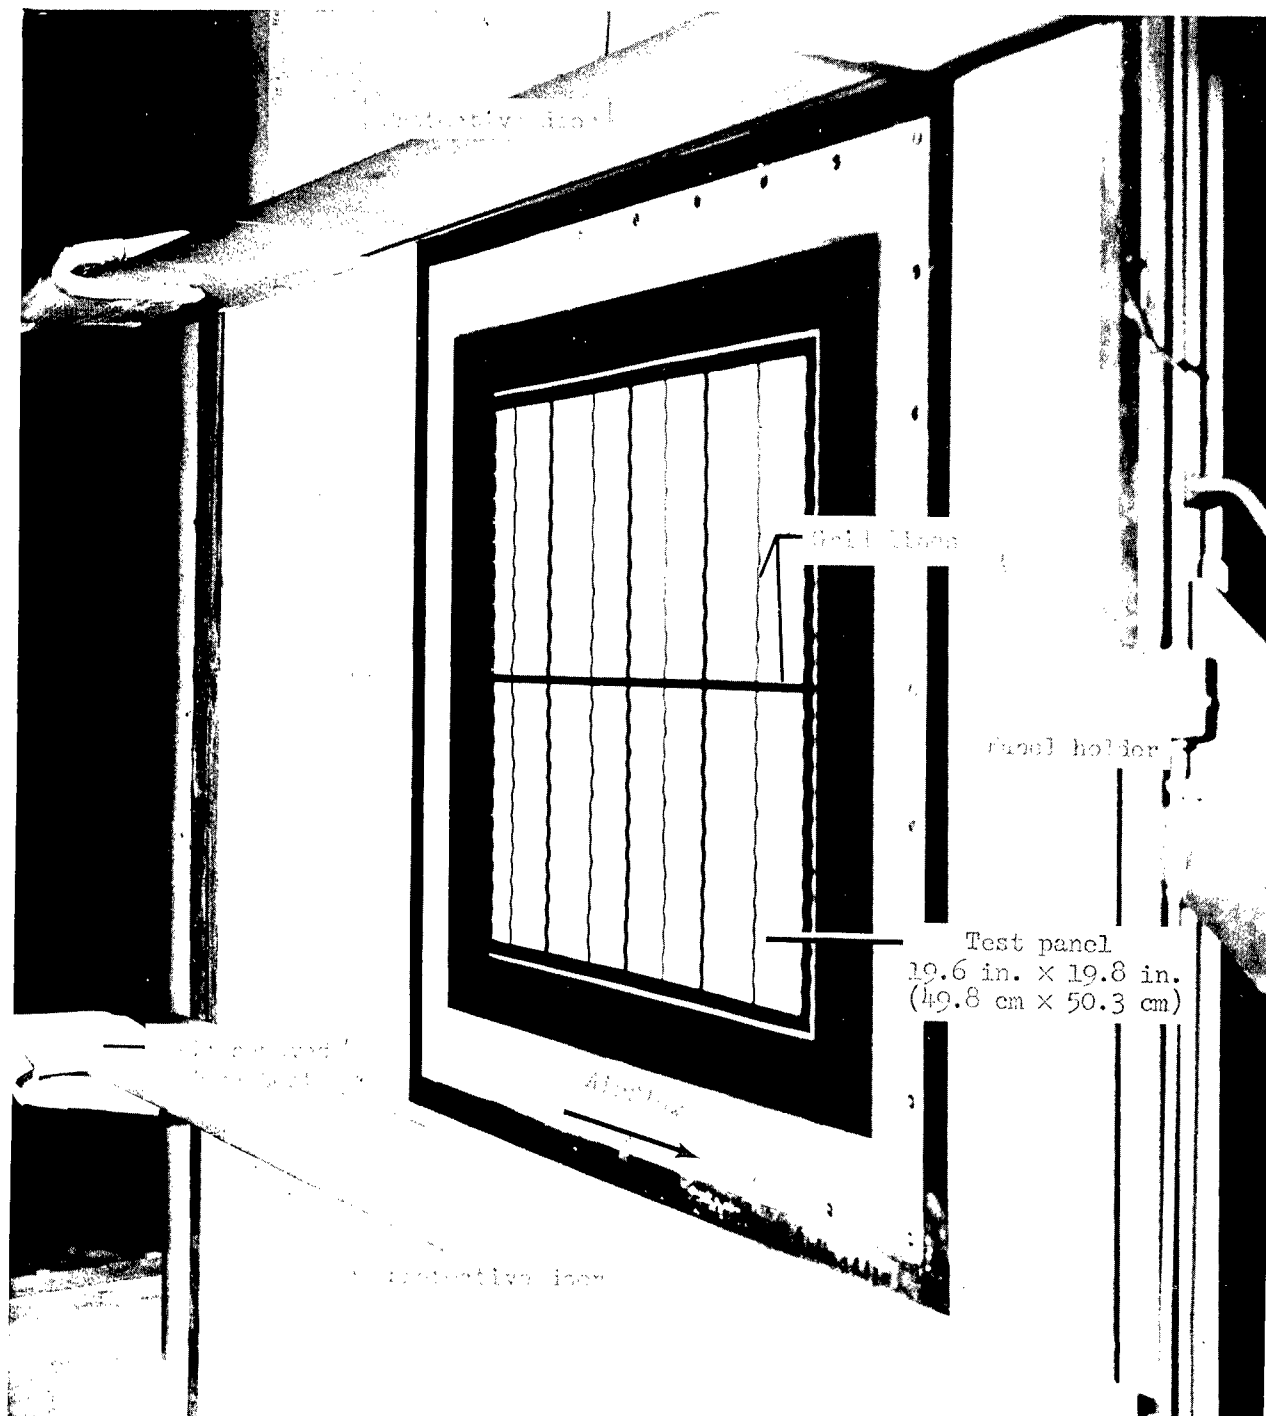
(a) Test panel mounted.

Figure 6.- Panel holder with protective doors in Langley 9- by 6-foot thermal structures tunnel.

(b) Test panel removed.

Wind-tunnel tests.- The nickel-alloy and columbium-alloy panels were tested under aerodynamic conditions in the Langley 9- by 6-foot thermal structures tunnel. The heat-shield panels were mounted in a panel holder at an angle of attack of 0° . (See fig. 6(a).) Airflow was at Mach number 3 with a stagnation temperature of 450°F (505°K), and the maximum temperature experienced by the panels was approximately 300°F (422°K). The nickel-alloy panel was subjected to stable free-stream dynamic pressures of $1,500\text{ lb/ft}^2$ (71.8 kN/m^2) and $2,500\text{ lb/ft}^2$ (120 kN/m^2) and the columbium-alloy panel was subjected to a stable free-stream dynamic pressure of $1,500\text{ lb/ft}^2$. The panels were aligned with the outer-skin corrugations first parallel and then perpendicular to the airstream at each dynamic pressure. The tunnel conditions were maintained for approximately 60 seconds. Sliding doors on the panel holder protected the panels from severe random pressure fluctuations which occur during tunnel starting and shutdown periods. (See fig. 6(a) and ref. 7.) After the doors were opened, the pressure differential across the specimen was maintained at less than $1/4\text{ psi}$ (1.72 kN/m^2) by means of an adjustable port on the panel holder.

Cameras and deflectometers were used to detect and record motion of the shields. Grid lines painted on the outer skin of the panels (fig. 6(a)) aided in the visual detection of motion. The cameras were operated at 750 and 250 frames per second. Six deflectometers were bolted to a heavy steel bar attached to the panel mounting frame to detect motion of the shields as shown in figure 6(b). The deflectometers were mounted $3/16\text{ inch}$ (0.476 cm) beneath the outer skin of the panel through $1\frac{1}{8}\text{-inch}$ (2.86-cm) holes in the primary structure and insulation. The inductance-type deflectometers are flat wire coils that are coupled by their electrical field with the resistance of the outer skin material to produce an electrical signal. The output signal limited the measurement of shield motions to inward deflections of $1/8\text{ inch}$ (0.318 cm) and to outward deflections of $1/16\text{ inch}$ (0.159 cm).

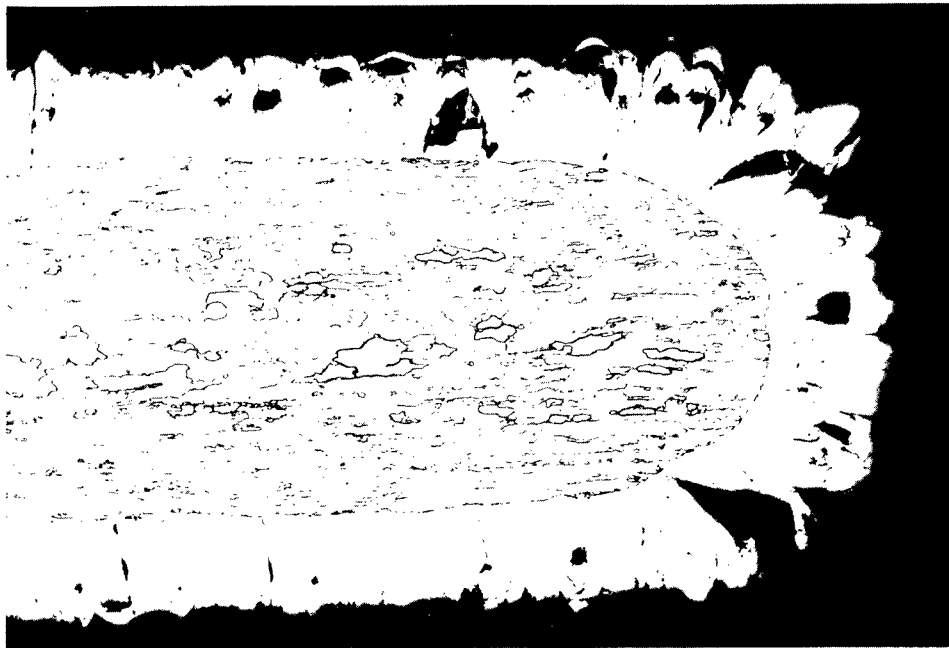
Figure 14.- Typical cross-sectional views of molybdenum-alloy sheet before and after coating. $\times 200$.

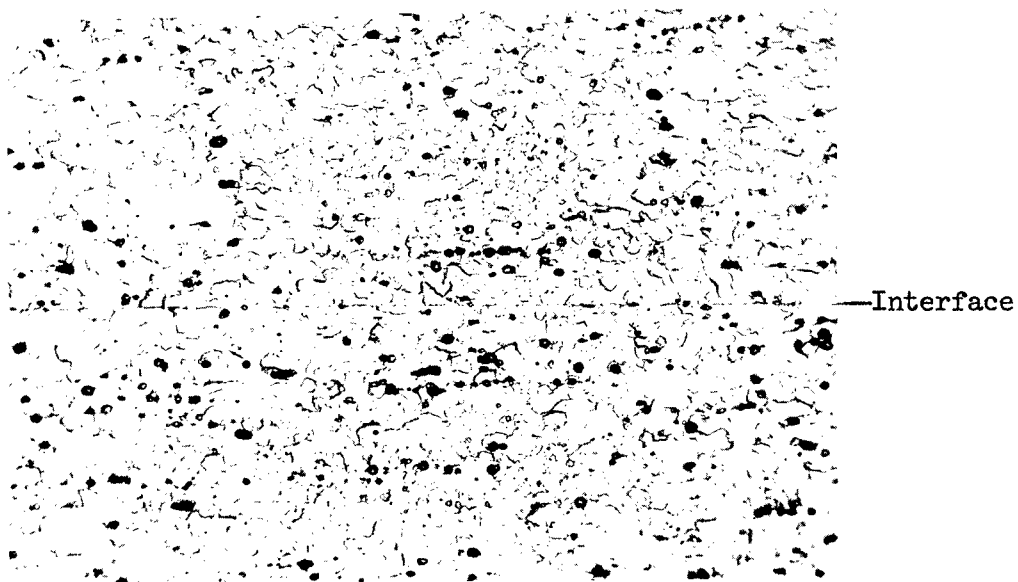
Figure 17.- Cross-sectional views of spot weld in 0.010-in. (0.254-mm) columbium-alloy sheets.
